Manhole Inspection Summary

Manhole # S53C__019MH

Inspection ☐ Is Incomplete Rating: **3) Fair**

Location Address: **1 n clinton st**

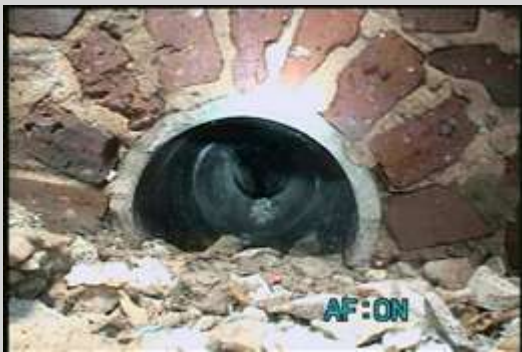
12 O'Clock Outflow

8 in. Circular Gravity Sewer
Pipe Out @ 12 O'Clock

Pipe Material: **Clay** ☐ Pipe Lined

Infiltration: **None** Pipe Seal Cond: **Unknown**
